DEPARTMENT OF TRANSPORTATION

Contract #: 04-0120F4Cty: SF/ALA Rte: 80 PM: 13.2/13.9File #: 69.28**WELDING INSPECTION REPORT****Resident Engineer:** Pursell, Gary**Address:** 333 Burma Road**City:** Oakland, CA 94607**Report No:** WIR-002614**Date Inspected:** 16-May-2008**Project Name:** SAS Superstructure**OSM Arrival Time:** 1330**Prime Contractor:** American Bridge/Fluor Enterprises, a JV**OSM Departure Time:** 2230**Contractor:** Zhenhua Port Machinery Company, Ltd (ZPMC), Changxing Island **Location:** Shanghai, China**CWI Name:** See below**CWI Present:** Yes No**Inspected CWI report:** Yes No N/A**Rod Oven in Use:** Yes No N/A**Electrode to specification:** Yes No N/A**Weld Procedures Followed:** Yes No N/A**Qualified Welders:** Yes No N/A**Verified Joint Fit-up:** Yes No N/A**Approved Drawings:** Yes No N/A**Approved WPS:** Yes No N/A**Delayed / Cancelled:** Yes No N/A**Bridge No:** 34-0006**Component:** Tower and OBG Fabrication**Summary of Items Observed:**

WELDING INSPECTION REPORT

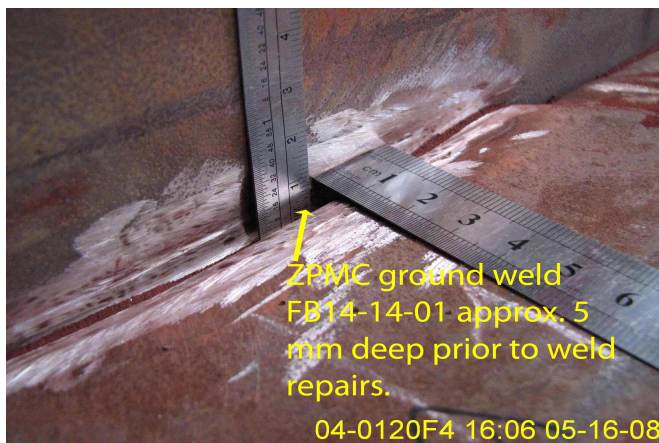
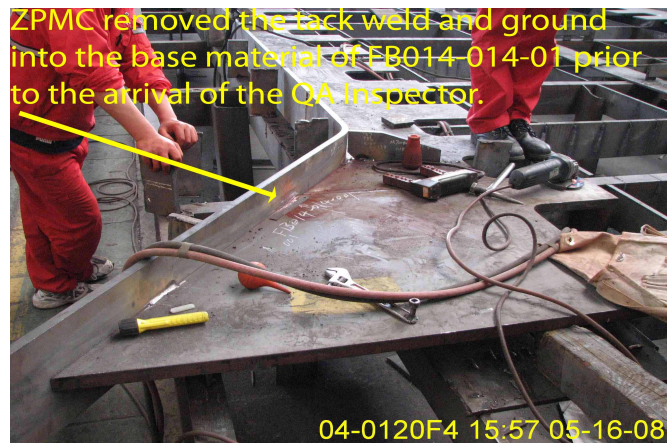
At around 1545 hours the QA Inspector was informed that ZPMC has identified one of the tack welds in floor beam FB014-014-001 has a weld crack. At approximately 1550 hours, (five minutes after notification) the QA Inspector arrived in bay 7 and the QA Inspector observed the cracked tack weld in floor beam FB014-014-001 has been ground out and the base material has been gouged to a depth of approximately 5 mm. Note: ZPMC performed this work prior to the arrival of the QA Inspector. The QA Inspector observed ZPMC QC magnetic particle inspector Mr. Cai Xinxin performing a magnetic particle inspection of the weld removal area and after the gouge had been ground to a depth of approximately 6 mm Mr. Cai Xinxin determined the crack had been removed and the MT inspection is acceptable. The QA Inspector measured the depth of the gouge to be approximately 6 mm deep. The QA Inspector also performed a visual and magnetic particle inspection of the gouged area and items observed appear to comply with project specifications. The QA Inspector performed random visual inspections of the other tack welds on floor beam FB014-014-001 and no other tack welds appear to have similar linear indications. Note: this plate is approximately 30 mm thick and based on the depth of the gouge the repairing of this gouge is not considered a critical weld repair. See TL-6027 report titled: "Magnetic Particle Test Report" and the two photographs below for additional information.
